| 技術基準適合確認書 | |
| 製 品 名 | デジタルミラー |
| 製 品 型 式 | DVR-DM1200A2+KTX-M01-A1 |
| 試 験 内 容 | 衝撃テスト |

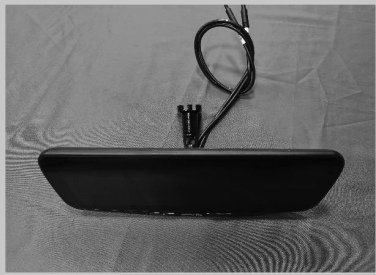
Before test-Front

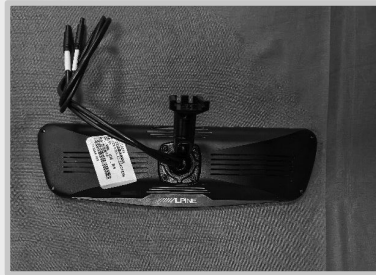
Before test-Back

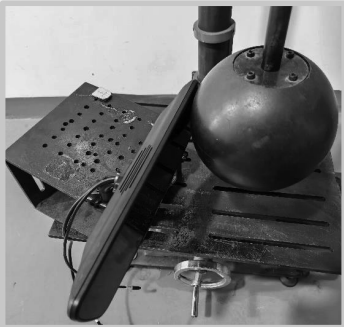
45° impact edge point

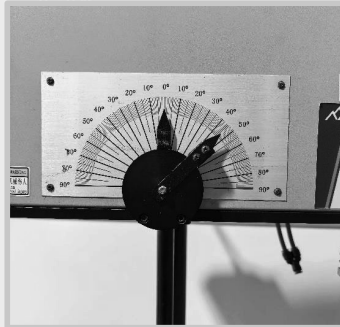
Angle after impact-46°

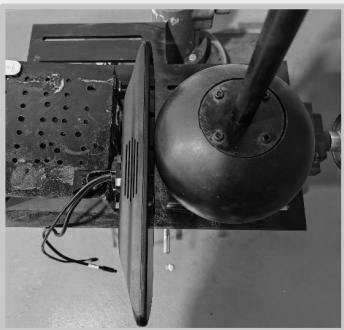
Central impact point

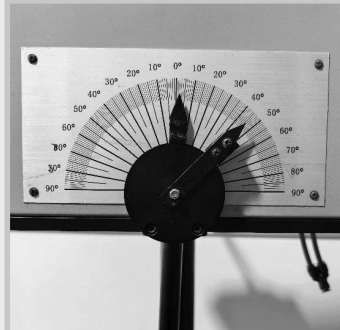
Angle after impact-45°

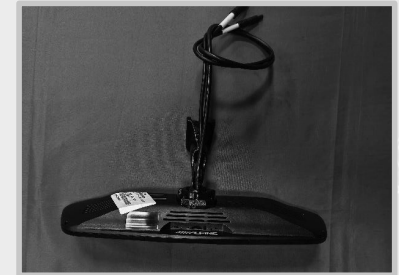
Visual Inspection-1

| 技術基準適合確認書 | |
|---|---|
| 試験結果 | 本製品は、下記適用技術基準に適合している。<br>・ガラスの破片がハウジングの背部、またはハウジングに固定された表面に固着していること。<br>・ガラスが基材から部分的に分離した場合は、割れ目の両辺が2.5mm以下であれば許容する。衝撃点において、ガラスの表面から小さな破片が剥離することは許容する。<br>・反射面は、安全ガラス製とする。 |

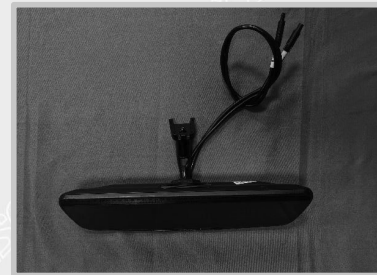
Visual Inspection-2

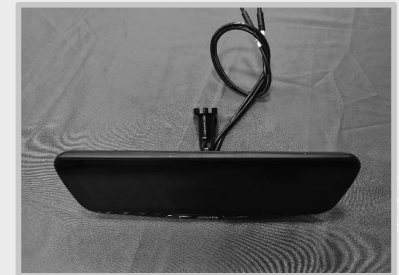
Visual Inspection-3
