| 技術基準適合確認書 | |
| 製 品 名 | デジタルミラー |
| 製 品 型 式 | DME-M01/DMR-M01R/DVR-DM1200A<br>(KTX-M01-A1CKD 使用時) |
| 試 験 内 容 | 衝撃テスト |

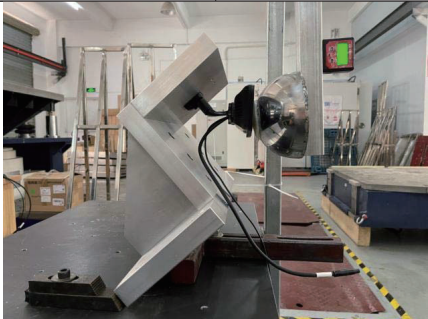
Fig.12 Test setup- 6# (Frontal Impact)

1.3.1 Frontal Impact: The ball head hits the reflective surface.

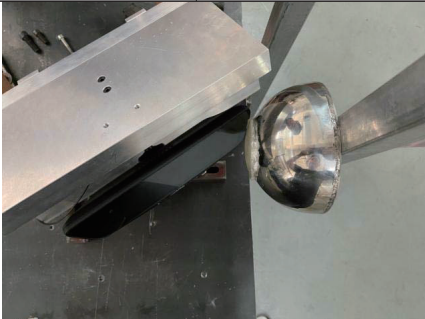
Fig.15 Test setup- 8# (45 ° angle Impact)

2.3.2 45 ° angle Impact: The reflective surface of the lens should form an angle of 45° with the original motion direction of the point on the sphere of the collision point, the collision direction should be towards the reflective surface, and the collision point should be the horizontal plane of the center of the lens reflective surface of the protective cover of the lens, which should pass through the edge.

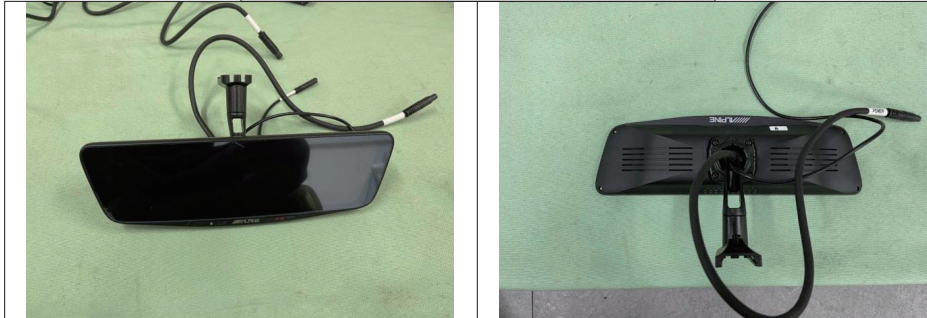
Fig.21 Appearance inspection after test- 8#

Fig.22 Appearance inspection after test- 8#

| Sample No. | Test result |
|---|---|
| 6#, 8# | The appearance of product is normal; The front and rear cameras of product is normal and button function of the product is normal. |
