| 技術基準適合確認書 | |
| 製 品 名 | デジタルミラー |
| 製 品 型 式 | DVR-DM1000A2+KTX-M01-A1 |
| 試 験 内 容 | 衝撃テスト |

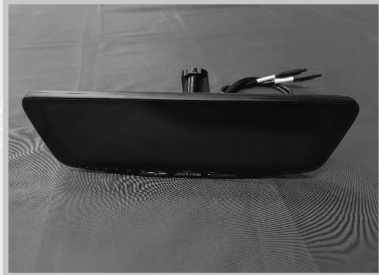
Before test-Front

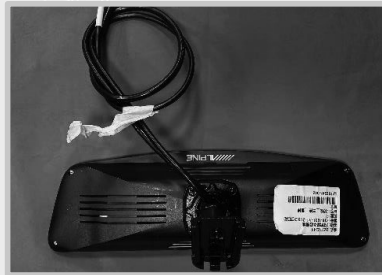
Before test-Back

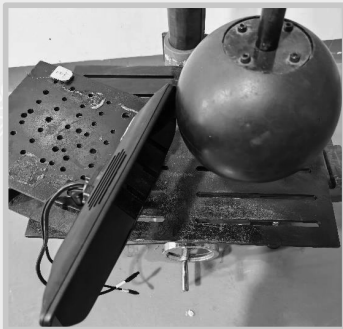
45° impact edge point

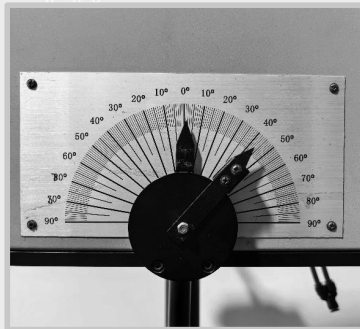
Angle after impact-43°

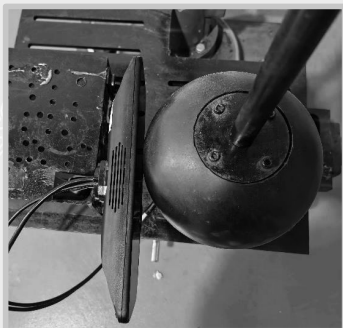
Central impact point

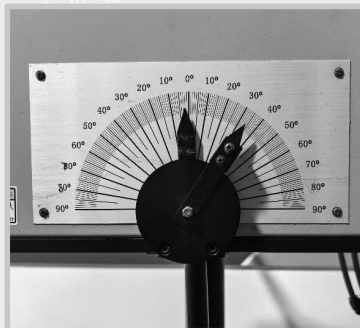
Angle after impact-33°

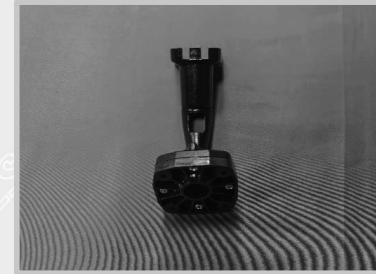
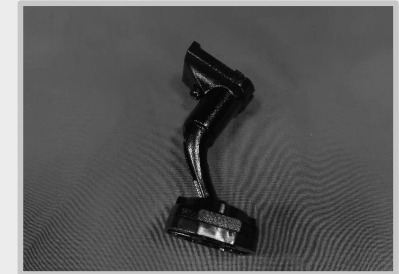
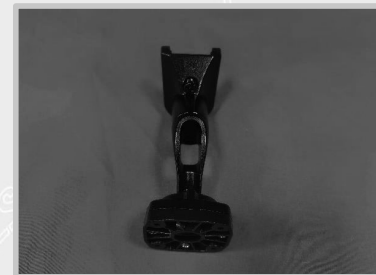
Bracket-1

Bracket-2

Bracket-3

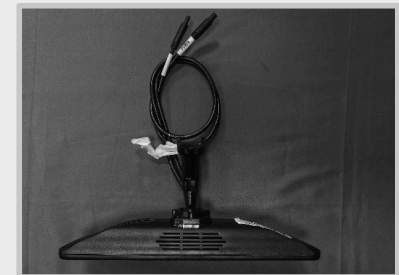
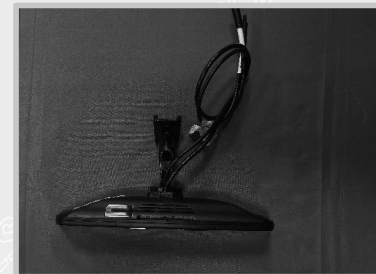
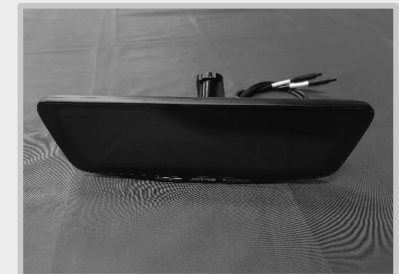
Visual Inspection-1

Visual Inspection-2

Visual Inspection-3

| 技術基準適合確認書 | |
|---|---|
| 試 験 結 果 | 本製品は、下記適用技術基準に適合している。<br>・ガラスの破片がハウジングの背部、またはハウジングに固定された表面に固着していること。<br>・ガラスが基材から部分的に分離した場合は、割れ目の両辺が2.5mm以下であれば許容する。衝撃点において、ガラスの表面から小さな破片が剥離することは許容する。<br>・反射面は、安全ガラス製とする。 |
